Spiromatic & Revitox breathing valve

This safety advice applies to all Spiromatic and Revitox breathing valves with serial number 1631001 to 2107999 and spare part kits containing valve inserts with manufacturing date August 1st, 2016 to February 9th, 2021. Older breathing valves may also be affected by this bulletin if they have undergone service and had valve inserts fitted that were manufactured during this period.

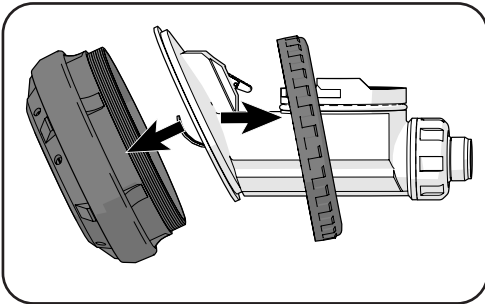
1. Remove the exhalation unit.

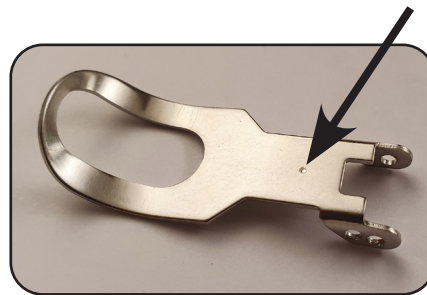
2. Check if the lever has a punched dot on it. If it has a dot, it is the new version and there are no need to check the lever height or inspect the surfaces of the lever support.

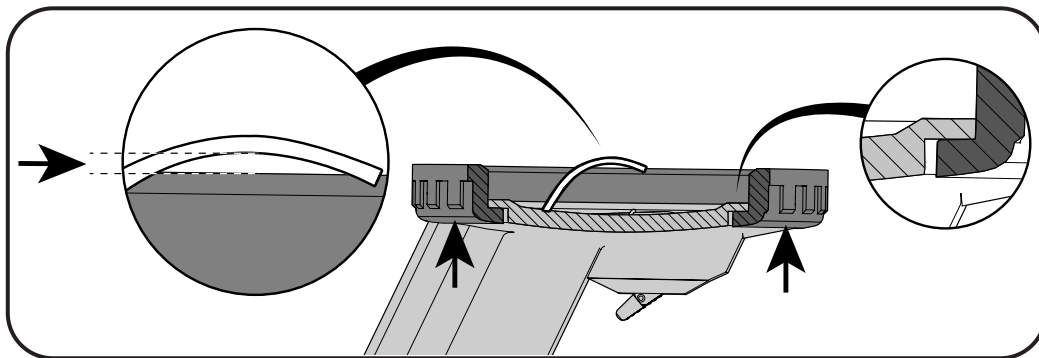
3. Check the lever height. If it is too low, replacement must be done before the next use, as this may be a sign of wear without visible damage.

Remove the exhalation unit except the locking ring. Push the locking ring upwards so that it lies against the edge. Check that you can see a gap between the lever and the upper edge of the locking ring. This test method is only for checking if the lever is too low and has no upper limit.

Important! Hold the breathing valve upwards as shown in the image.

Important! It is not permitted to manually bend the lever to make a gap.

- If damage is detected, or if the lever height is too low, the replacement must be carried out **before using the breathing valve again.**
- If no damage is detected and the lever height is within the approved range, the parts must be replaced **at the next annual service.**

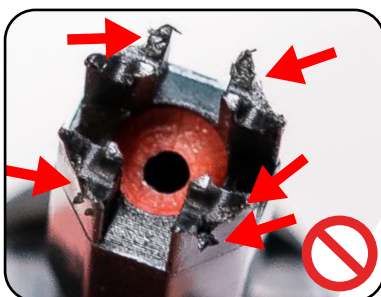
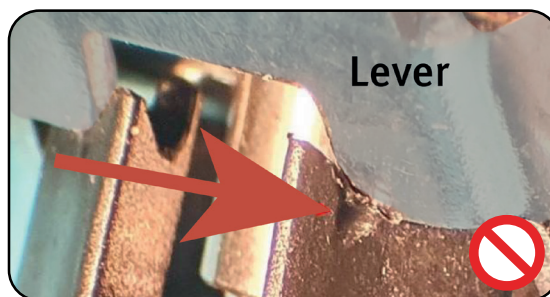
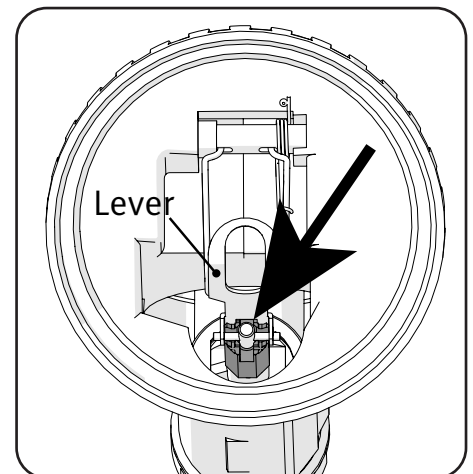
4. Check the contact surfaces on the lever support.

Check that the contact surfaces and the outside surface of the lever support is undamaged. If it is damaged like indicated by the red arrows in the images, the parts must be replaced before the next use.

Note! The images shows damages on a Divator lever support.

By replacing the lever with a new version the risk of this failure mode is eliminated. The lever support with sealing diaphragm must be replaced at the same time. The replacement procedure is required to be performed by a certified service technician according to the instructions detailed in Service Bulletin 34275B01US.
